SCHEDULE OF CONDITION

Islington
London. N1 XXX

FRONT EXTERNAL ELEVATION

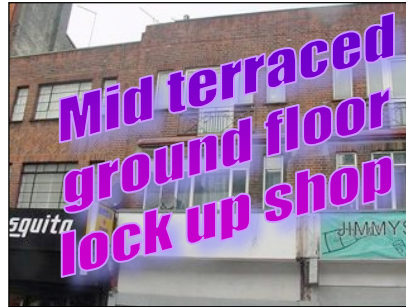
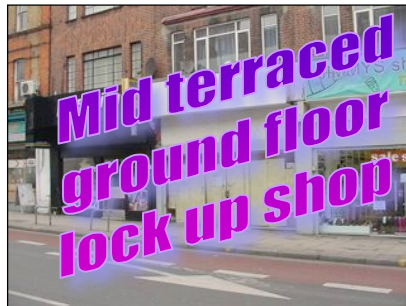
DESCRIPTION	CONDITION	ACTION REQUIRED
Roofs: Pitched (assumed) but not visible		If there is a liability Legal Advisor to instruct.
Gutters and Downpipes: Cast iron and plastic		Ensure all gutters are watertight and falling towards the downpipe. Repair and secure as necessary, ensure downpipes are clear.
Walls: Flemish bond brickwork	Dirty and stained	Clean

<p>External Detailing:</p> <p>Shop Front Window: Single glazed, metal frame</p>   <p>Shop Entrance Door: metal, glazed</p> <p>Signage: None, plywood thick only</p>   <p>Lights: None visible</p>	<p>Dirty</p> <p>No insulation</p>	<p>Clean, make good.</p> <p>Make good and build to normal building standards. Re-instate signage and infill wall.</p> <p>Add lights</p>
--	-----------------------------------	---

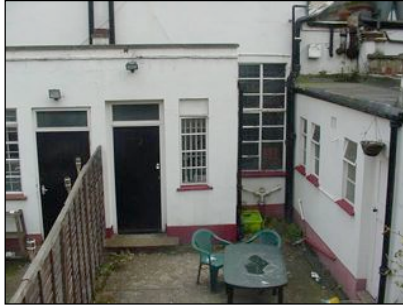
REAR ELEVATION

DESCRIPTION	CONDITION	ACTION REQUIRED
Roofs: Main Roof: Pitched (assumed) not visible Flat Roofs:- Flat roof over the shop

Not visible Generally there is a lack of falls to the flat roofs which has lead to water damage internally which is visible and also old repairs can be seen.

Water sitting on roof, we believe this is getting into the property.	If there is a liability Legal Advisor to instruct. All flat roofs need falls adding and the detailing improving.

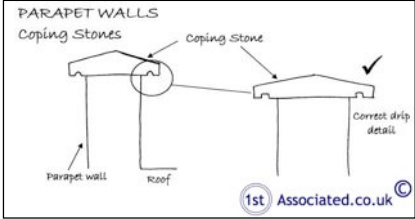
<p>Up stand</p>

<p>Appear to be allowing in water.</p> <p>Not adequate size.</p>

<p>Missing coping stone to parapet wall toilet area</p> <p>Vegetation present</p>	<p>Replace/improve flashings ideally to be formed in lead.</p> <p>Make watertight, this may require adding new coping stones as incorrect see sketch.</p> <p>Remove vegetation</p>
<p>Gutters and Downpipes:</p> <p>Cast iron and plastic</p>	<p>Rust visible</p>	<p>Remove rust and paint with rust stop paint. Ensure all gutters are watertight and falling towards the downpipe. Repair and secure as necessary, ensure downpipes are clear.</p>
<p>Walls:</p> <p>Flemish bond brickwork</p>	<p>Dirty and stained</p>	<p>Clean</p>

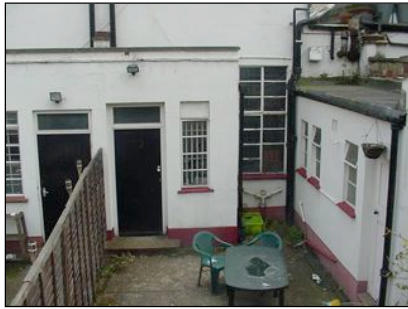
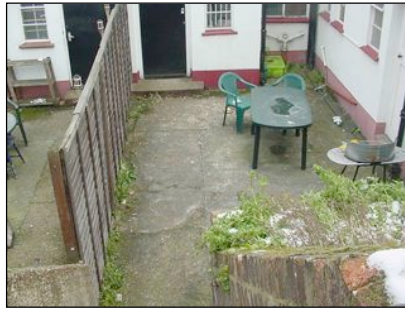
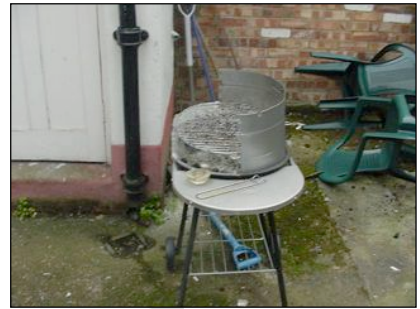
REAR COURTYARD AREA

DESCRIPTION	CONDITION	ACTION REQUIRED
Walls: Retaining wall	Degraded by ground water coming through it

Make good any trip hazards. Clear vegetation
Steps: Concrete	Some wear	Make good
Fence: Panelled		Re-stain/paint
Drains:	Blocked	Clear

Add weep holes to relieve pressure on wall and make good wall.
Ground: Concrete	Uneven. Vegetation

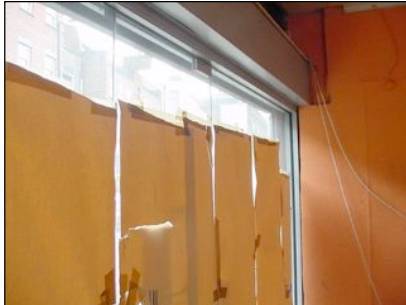
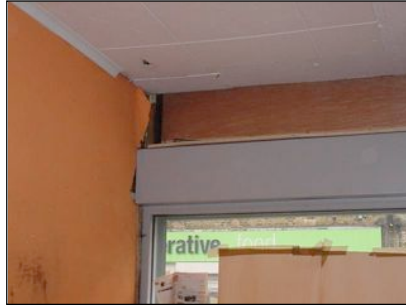
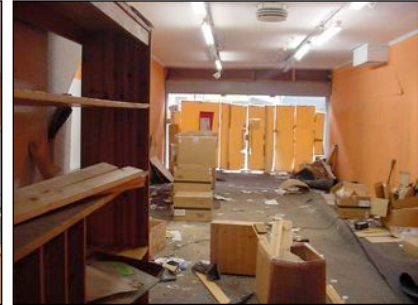
Shop Trading Area Front elevation

DESCRIPTION	CONDITION	ACTION REQUIRED
Ceilings: Foam/polystyrene tile	Fire hazard

Water damaged	Remove. Replace with modern ceiling system to current Fire Regulation requirements. Ensure that roofs above are watertight before carrying out work.
Floors: Concrete centrally with wooden flooring on batons to outside.	Worn	Replace entirety of floor
Detailing: Metal window frame: single glazed.	Dirty, marked.	Clean and repair.
Doors: Two glazed double doors.	Dirty	Clean.
Services: Heater/vent in centre of room		Remove/improve

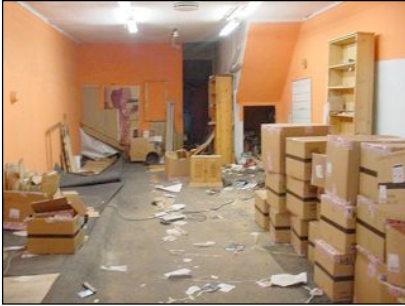
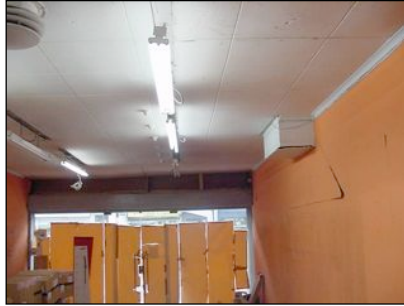
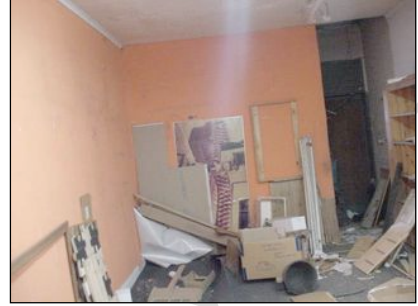
Shop Trading Area
Left elevation

DESCRIPTION	CONDITION	ACTION REQUIRED
Ceilings: Foam/polystyrene tile Lighting: Older style	Dated, considered a fire hazard. Stained, looks to be coming from the small flat roof above Dated	Remove. Replace with modern ceiling system to current Fire Regulation requirements. Ensure that roofs above are watertight before carrying out work. Remove replace with Category 2 lighting

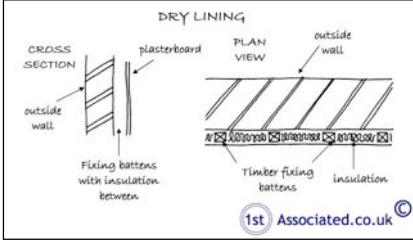
<p>Walls:</p> <p>Painted woodchip paper</p> <p>False walls otherwise known as dry lining.</p>

<p>Marked</p>	<p>Repair, prepare and redecorate.</p>
<p>Floors:</p> <p>Concrete centrally with wooden flooring on batons to outside.</p>	<p>Worn</p>

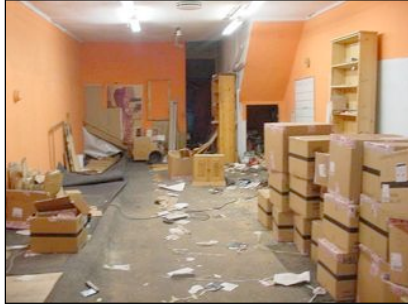
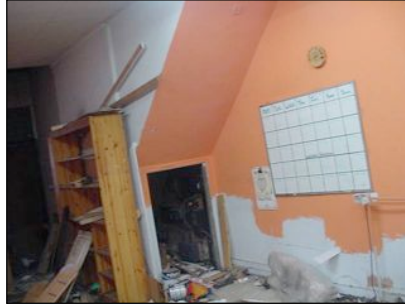
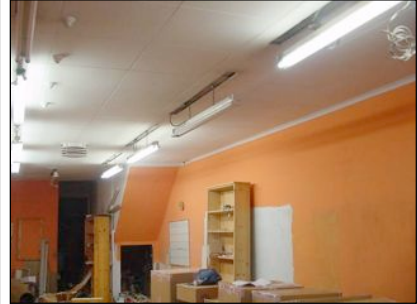
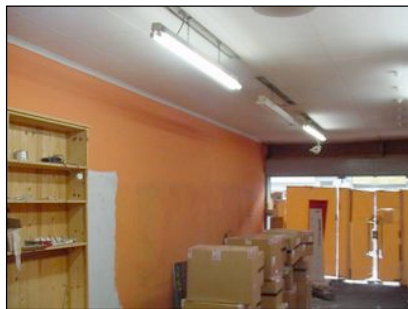
Shop Trading Area
Right elevation

DESCRIPTION	CONDITION	ACTION REQUIRED
Ceilings: Foam/polystyrene tile Lighting: Older style	Dated considered a fire hazard. Dated	Remove. Replace with modern ceiling system to current Fire Regulation requirements. Remove replace with Category 2 lighting

Walls: Painted woodchip paper False walls otherwise known as dry lining.	Marked	Repair, prepare and redecorate.
Floors: Concrete centrally with wooden flooring on batons to outside.	Worn	Replace entirety of floor
Detailing: Door: To staircase		Replace with a fire door
Staircase: To rear with stairs sanforded from ceiling		Landlord to confirm this staircase has been built to fire safety standards.
Services: Electrics:	Dated. Service mounted electric points, earth check proved satisfactory.

Re-wire to Institute of Electrical Engineers (IEE) standard by an NICEIC approved electrician or equivalent.

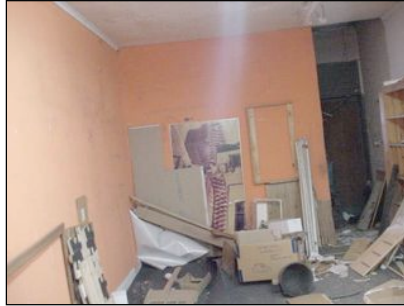
Shop Trading Area
Rear elevation

DESCRIPTION	CONDITION	ACTION REQUIRED
Ceilings: Foam/polystyrene tile To rear: wood slated ceiling

Dated considered a fire hazard. Needs removing	Remove. Replace with modern ceiling system to current Fire Regulation requirements. Remove and upgrade.
Lighting: Older style	Dated	Remove replace with Category 2 lighting
Walls: Painted woodchip paper Studwork partition	Marked	Repair, prepare and redecorate.
Floors: See front elevation		
Services Boiler on rear wall Surface mounted conduit		Replace Replace

You advised this is going to be removed; you will need to get the landlord's permission and consent for this.

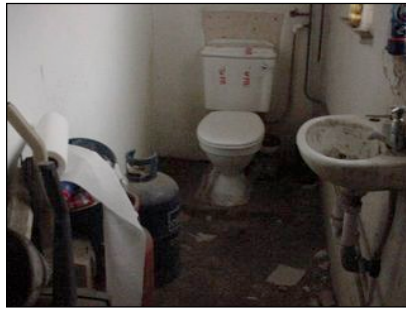
Toilet and wash area

DESCRIPTION	CONDITION	ACTION REQUIRED
Ceiling: Plastered	Signs of water penetration to left hand side from the flat roof above. Please see our comments on the rear elevation	Make watertight. Prepare, repair and redecorate
Walls: Plastered

Long term dampness coming through the walls

Floors: Wood	 Marked	 Replace.
Detailing: Windows: Metal, single glazed	We believe the metal windows may be beyond repair. Broken glass needs replacing.	Prepare, repair and redecorate. We recommend secondary glazing in this area
Services: Water not on at the time of our inspection.

Make watertight. Prepare, repair and redecorate
