SCHEDULE OF CONDITION

XXXX

Mr X

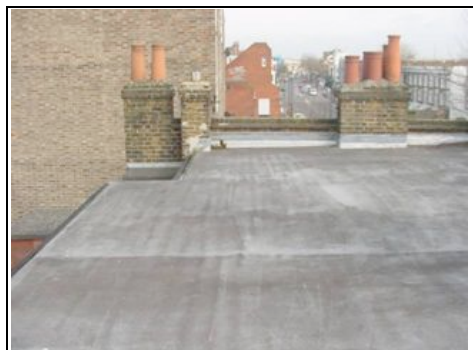
Main roof

DESCRIPTION	CONDITION	ACTION REQUIRED
Flat roof: Asphalt	Cracking visible within asphalt	Ad hoc repairs Over the period of the Lease we would expect the roof to require major repairs if not renewal
Chimneys: Numerous Brickwork	Ad hoc repairs required	Ad hoc repairs

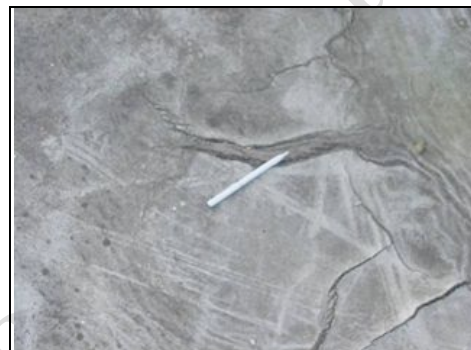
Cracking to asphalt

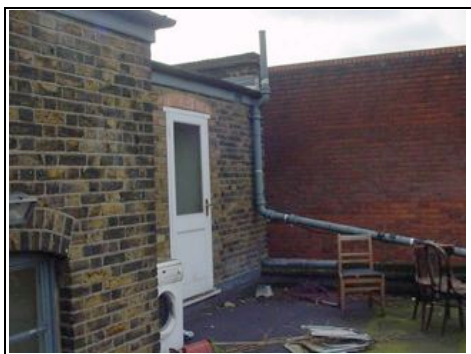
Rear two storey roof

DESCRIPTION	CONDITION	ACTION REQUIRED
<p>Flat roof: Asphalt</p> <p>There are doors leading out to this area but no safety rail around the edge of the roof.</p>	<p>Debris</p> <p>Point load damage</p> <p>Redundant pipework around and adjacent to the roof</p>	<p>Remove</p>

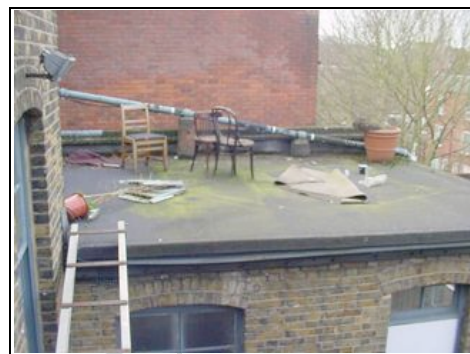
Debris on rear left roof

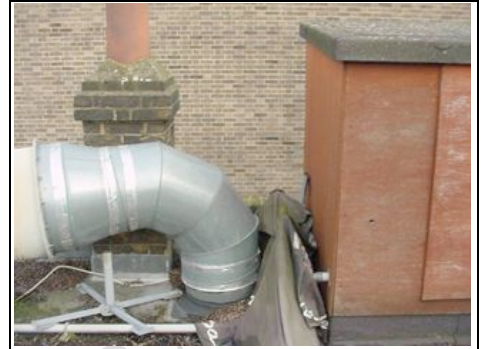
Roof – rear right

DESCRIPTION	CONDITION	ACTION REQUIRED
Flat Roof: Asphalt No fall	Debris Leaves gathering at base of property	Remove
Chimneys: Brickwork	Ad hoc repairs	Ad hoc repairs

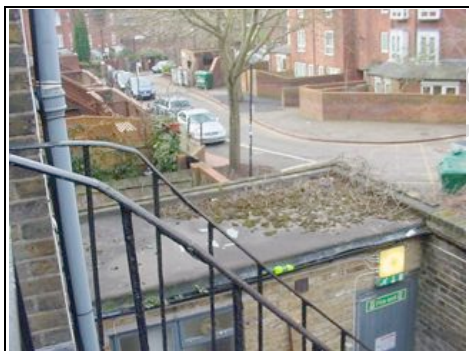
Rear low level roof

DESCRIPTION	CONDITION	ACTION REQUIRED
Flat Roof: Asphalt	Leaves and moss sitting on the roof indicating lack of fall to roof	Clear

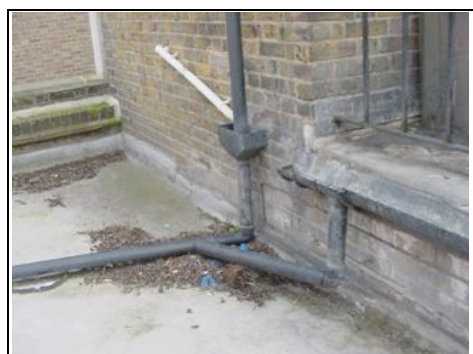
Low level single storey roof

DESCRIPTION	CONDITION	ACTION REQUIRED
Flat Roof: Asphalt Metal fire escape

<p>Gutters and Downpipes:</p> <p>Plastic</p> <p>Hopperhead</p>	<p>Running horizontally</p> <p>Full of debris</p> <p>Overflowing</p>	<p>Ensure all gutters are watertight and falling towards the downpipe and clear.</p> <p>Repair downpipes and secure as necessary, ensure downpipes are clean and clear.</p>
<p>Safety Rail:</p> <p>Metal</p>	<p>Dated</p>	<p>Remove rust. Use rust stop agent. Prepare, repair and redecorate.</p>

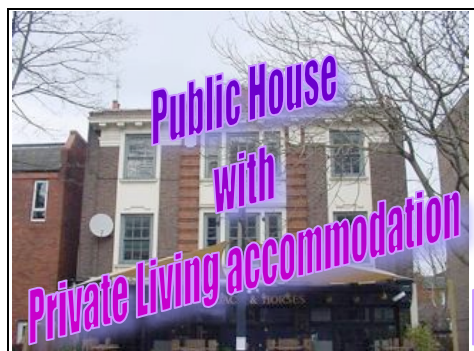
Front Elevation

DESCRIPTION	CONDITION	ACTION REQUIRED
Roofs:		Please see roof section
Parapet Wall: Brickwork		Please see roof section
Gutters and Downpipes: Cast Iron and Plastic		Please see roof section
Walls: Flemish bond brickwork Painted Render Glazed tiles	Dated Dated. Graffiti Cracked	Clean Clean graffiti and redecorate if required Repair

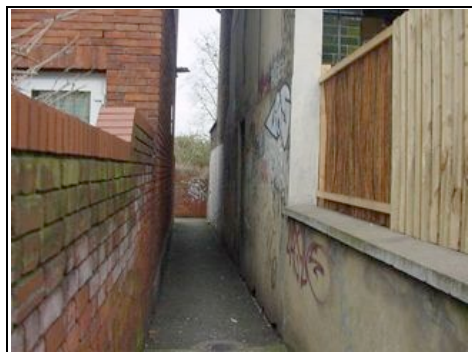
Left view

DESCRIPTION	CONDITION	ACTION REQUIRED
Roofs:		See roof section.
Gutters and Downpipes: Cast Iron and Plastic		See roof section.
Walls: Flemish bond brickwork White painted panel Render	Graffiti covered	Clean graffiti and redecorate if required.

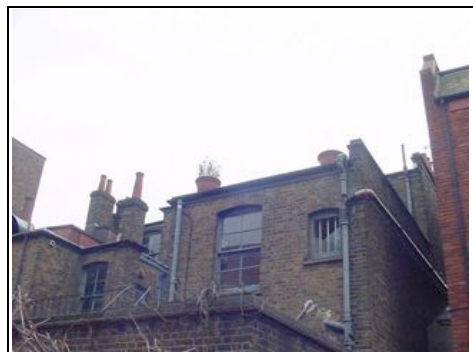
Rear view

DESCRIPTION	CONDITION	ACTION REQUIRED
Chimneys: Brickwork		See roof section.
Roofs:		See roof section.
Gutters and Downpipes: Cast Iron and Plastic	Leaking Waste pipes going into rainwater pipes	Make watertight. Adjust pipework

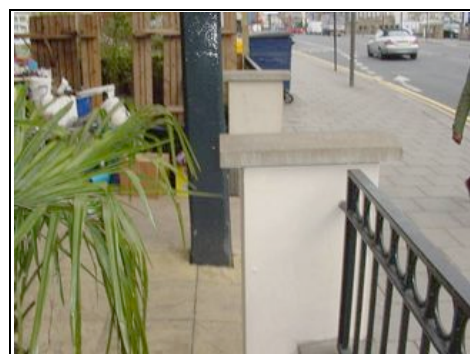
Rails

DESCRIPTION	CONDITION	ACTION REQUIRED
Front beer garden area Paved Rendered wall with metal railing	Dated Dated, damaged render	Pressure hose and clean Repair, prepare and redecorate

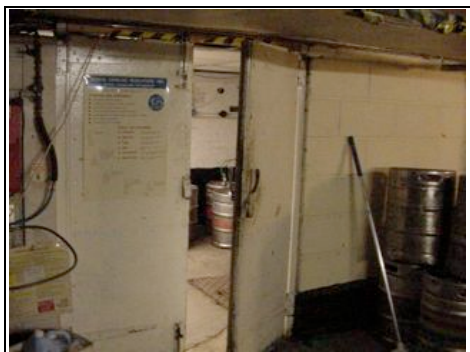
Cold cellar

Not to Environmental Health Standards

DESCRIPTION	CONDITION	ACTION REQUIRED
Ceilings: Suspended ceiling system Behind ceiling joist and floorboard with embedded timbers	Dampness/deterioration to approx quarter of ceiling Approx one tenth of ceiling missing Mould and marked Rot	Make watertight Supply and fit new insulated ceiling

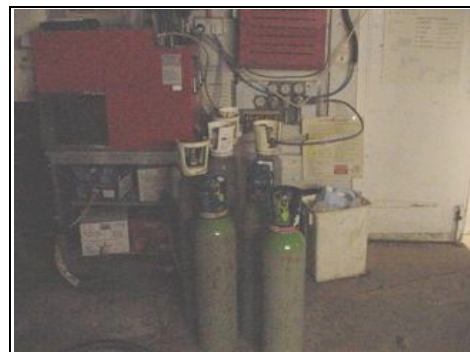
Gas cylinders not chained

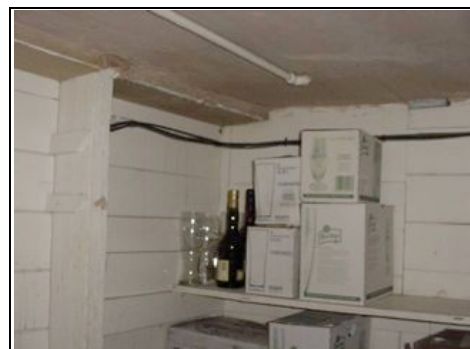
View of wine store

DESCRIPTION	CONDITION	ACTION REQUIRED
Ceilings: Painted Joist and floorboard with embedded timbers	Dated Rot	Repair, prepare and redecorate.
Walls: Painted brickwork Painted timber	Flaking and stained Dated	Repair, prepare and redecorate. Repair, prepare and redecorate.
Floors: Concrete	Damaged	Screed and add floor paint.

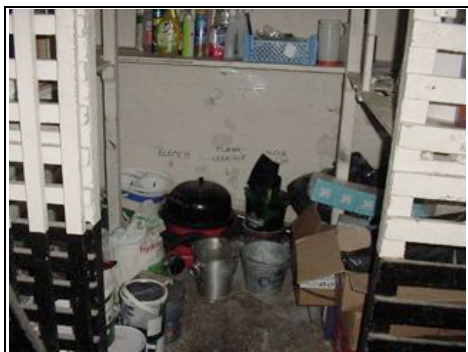
Store

DESCRIPTION	CONDITION	ACTION REQUIRED
Ceilings:		
Painted	Dated	Repair, prepare and redecorate.
Behind ceiling joist and floorboard with embedded timbers	Rot	
Walls:		
Painted	Dated	Repair, prepare and redecorate.
Timber division wall	Dated	Sand, repair, prepare and re-stain.
Floors:		
Concrete	Dated	Screed and add floor paint.
Detailing:		
Wood slated shelves	Dated	Sand, repair, prepare and re-stain.
Comments:		
Stored items	Mass of general stored items and point of sale goods	Remove

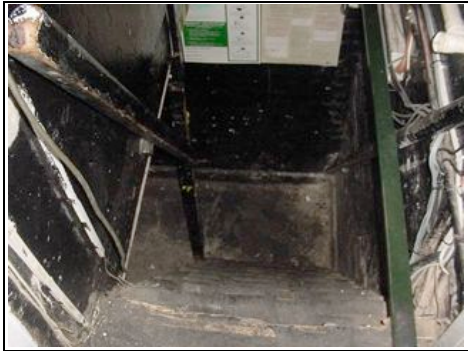
Steep ladder steps

DESCRIPTION	CONDITION	ACTION REQUIRED
Steps: Steep Hand rail	Dated	Repair, prepare and redecorate. Secure

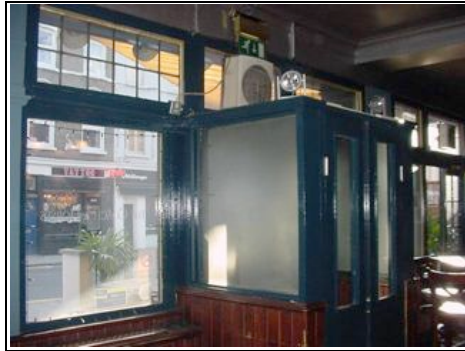
Entrance lobby

DESCRIPTION	CONDITION	ACTION REQUIRED
Walls: Glazed Boarding	Damaged	Sand. Repair, prepare and re-stain.

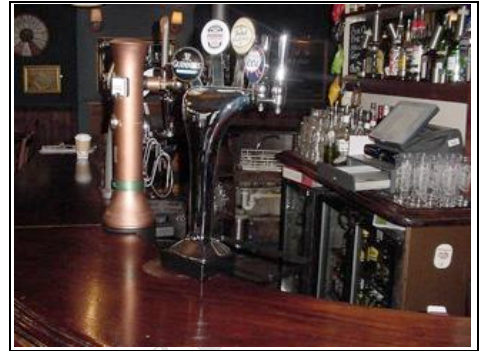
Bar servery

DESCRIPTION	CONDITION	ACTION REQUIRED
Ceilings: Painted	Dated	Repair, prepare and redecorate.
Floors: Altro style Tiled area around central servery	Ingrained dirt	Deep clean Clean

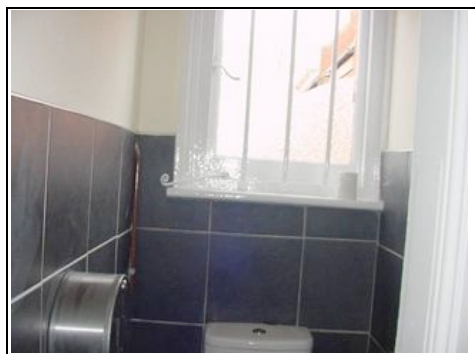
Broken window

DESCRIPTION	CONDITION	ACTION REQUIRED
Ceilings: Painted	Newly painted	
Walls: Painted Tiled to approx 1.5m	Newly painted Modern	
Floors: Tiled	Ingrained dirt	Deep clean
Sanitary Ware: WC	Ingrained dirt	Deep Clean
Detailing: Windows: Doors:	Broken Newly painted	Repair, prepare and redecorate.

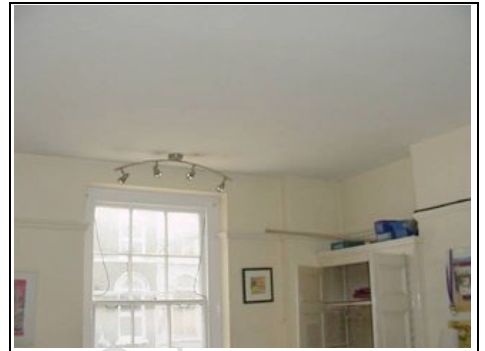
Office ceiling

DESCRIPTION	CONDITION	ACTION REQUIRED
Ceilings: Papered	Staining right corner	Repair, prepare and redecorate.

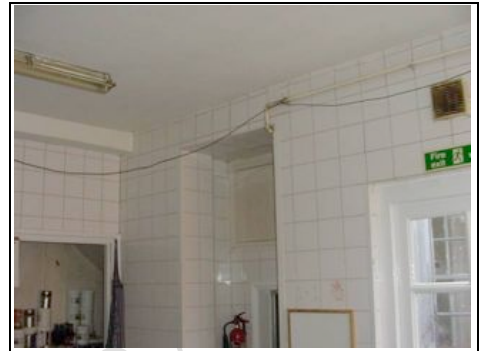
Walls

DESCRIPTION	CONDITION	ACTION REQUIRED
Ceilings: Painted Three bulk head lights	Dated Paint marked	Repair, prepare and redecorate. Clean
Walls: Floor to ceiling tiles	Ingrained dirt	Deep clean

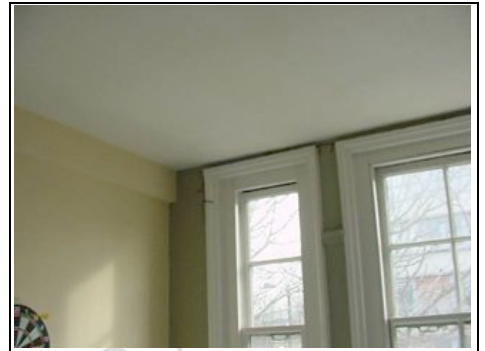
Windows

Detailing:		
Windows:		
One 6x6 sliding sash window	Dated	Repair, prepare and redecorate.
Two 2x2 sliding sash windows	Dated	Repair, prepare and redecorate.
Door: Painted panel	Dated	Repair, prepare and redecorate.
