# SCHEDULE OF CONDITION

Thetford  
Norfolk  
IP24 XXX

We have been instructed to inspect and prepare a Schedule of Condition for XXXX, Norfolk. IP24 XXX. We inspected the property on XXXX

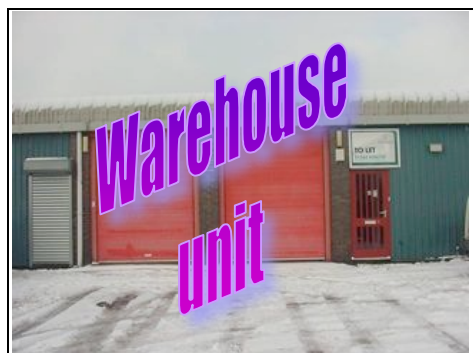
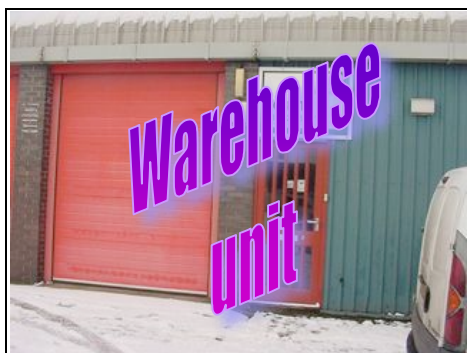
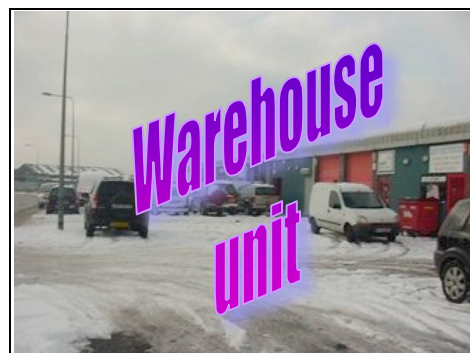
Front Elevation

Metal box gutter Three joints bolted together over length of front elevation   Downpipe going directly into the ground.	We viewed the gutters from ground level. Pattern staining and leaking.

Icicle indicates leaking   Leaks to joints	Ensure all gutters are watertight and falling towards the downpipe and clear. Repair downpipes and secure as necessary, ensure downpipes are clean and clear.

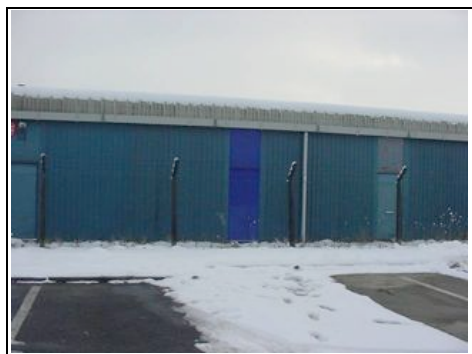
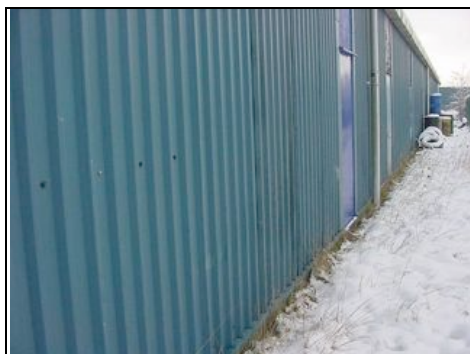
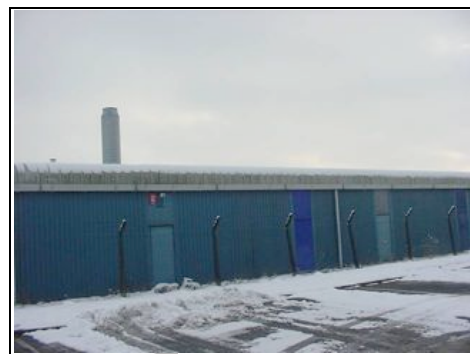
Rear elevation

Pattern staining.  Leaking. Moss covered  Pattern staining Leak to central joint	Ensure all gutters are watertight and falling towards the downpipe and clear.  Repair downpipes and secure as necessary, ensure downpipes are clear and clean.

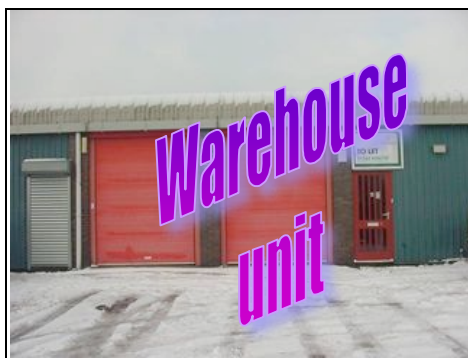
Roof covered with snow at time of survey

DESCRIPTION	CONDITION	ACTION REQUIRED
<b>Roofs:</b>  Profile metal sheet	Snow covered.  We have not be able to view the roof due to the snow but have been advised that the roof is leaking by adjoining occupiers and has been to the best of their knowledge been leaking for many years. This was confirmed by other occupiers.  Pattern staining to curved front of the roof internally.	Joint high level inspection with the landlord's surveyor to be carried out prior to signing of the lease or legal completion of the lease from high level cherry picker or equivalent. Or exclude roof from lease.

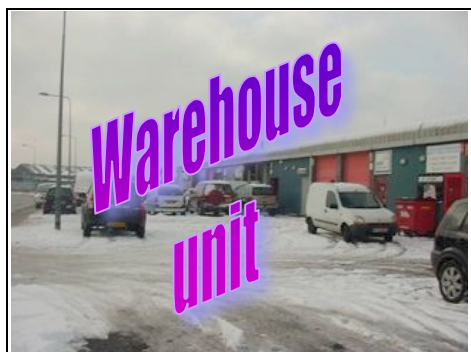
Car Park

DESCRIPTION	CONDITION	ACTION REQUIRED
Front Car Parking	Snow covered. Unable to establish if white lined, drainage or quality of surface coating.	
Rear Fire Exit passageway	Unable to view ground as snow covered.	
Rear Boundary Fence Concrete post with chain link fence

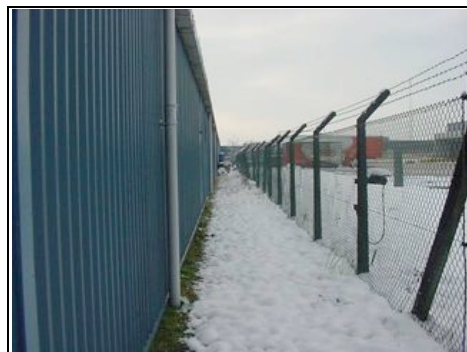
Rear Passageway

Post directly opposite rear of property is not vertical	Secure fencing assumed owned. If not landlord to write to owner to secure fencing.

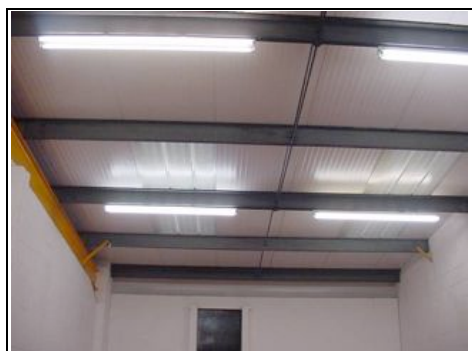
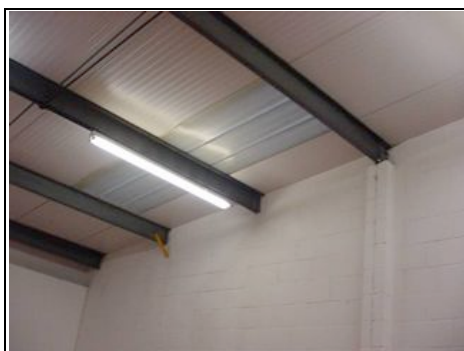
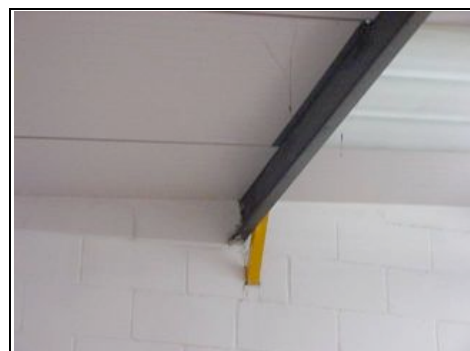
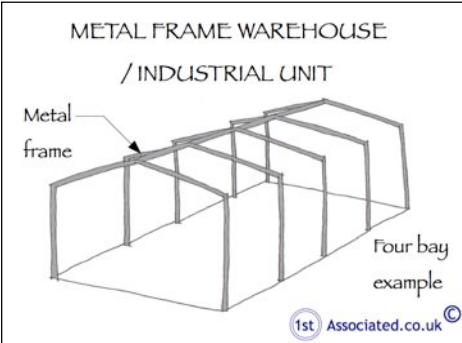
<p>Purlins marked Cobwebs, dirt and dust</p>

<p>Leak to front</p>	<p>High level clean</p> <p>Make roof watertight</p>

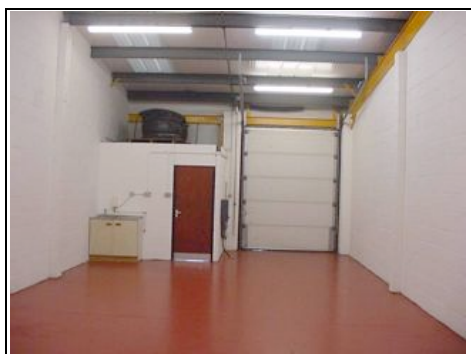
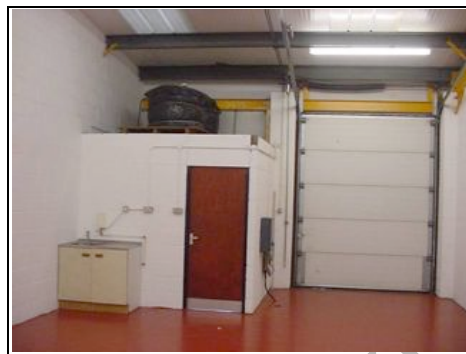
DESCRIPTION	CONDITION	ACTION REQUIRED
<b>Walls:</b>  Painted brickwork  	Paint from floor on walls. Newly painted. May be hiding latent defects such as the leaking roof.	
<b>Columns:</b> Either side of roller shutter door Painted brickwork  <b>Left side</b>  <b>Right side</b>	  Cracking Marks at base    Cobwebs Paint staining	Monitor. Repair, prepare and redecorate.  Clean. Repair, prepare and redecorate.

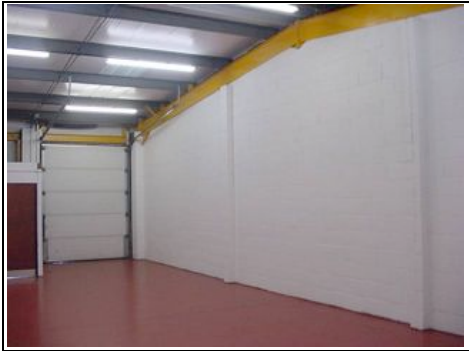
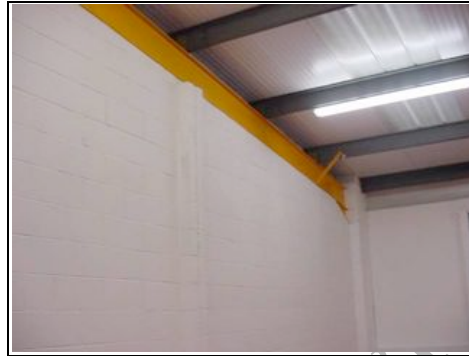
Marks, particularly at low level.  Newly painted	Repair, prepare and redecorate.

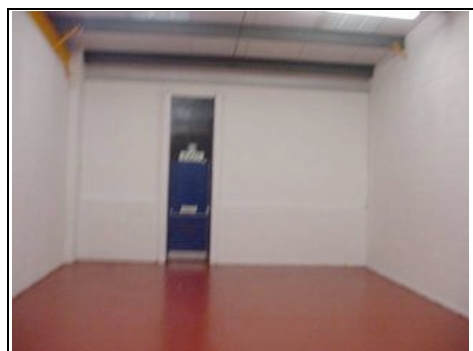
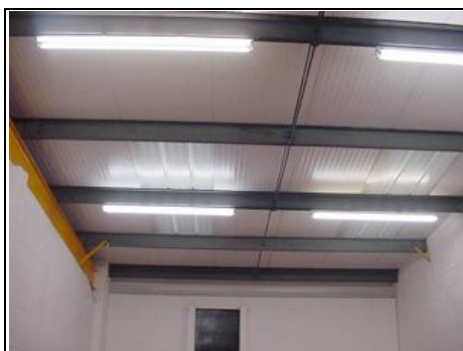
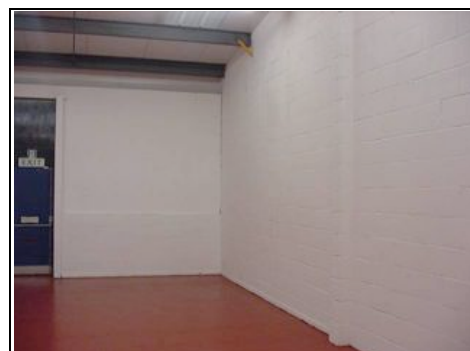
DESCRIPTION	CONDITION	ACTION REQUIRED
<b>Walls:</b> Metal purlin Asbestos Blockwork Two mastic joints to each corner	Possible cold bridging.

Asbestos Marked

Stepped cracking left side	Asbestos test and report. Note we are not asbestos surveyors.  Repair, prepare and redecorate.  Monitor.

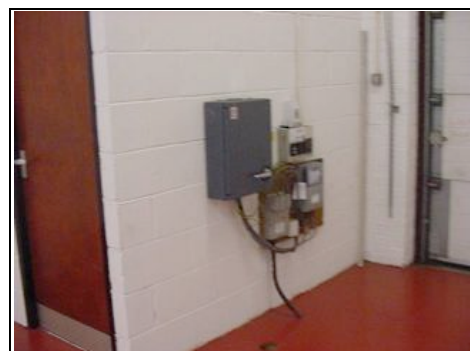
Electrics

Open electric system	Recommend electrics boxed in with an hour fire resistant unit Provide Institute of Electrical Engineers Certificate carried out by an NICEIC qualified electrician or equivalent.

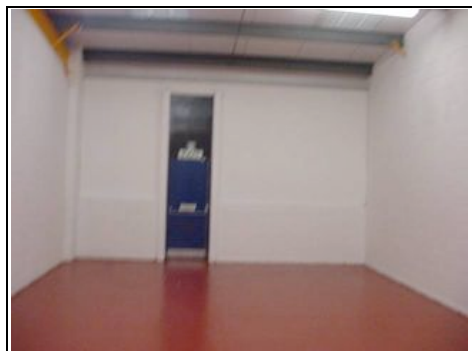
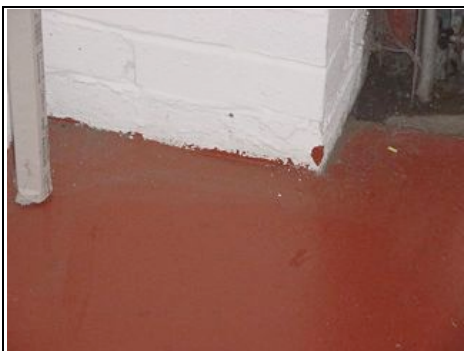
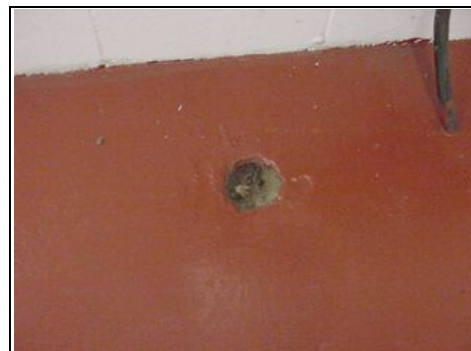
Newly painted  No pre-preparation has taken place  Marks and indents including fixing holes  Mark has stained some of the walls.	Prepare, repair and redecorate.

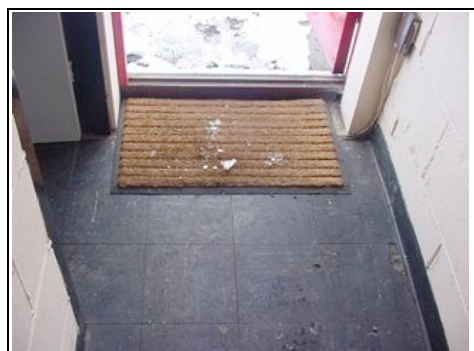
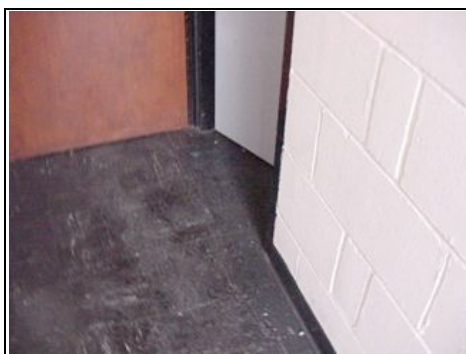
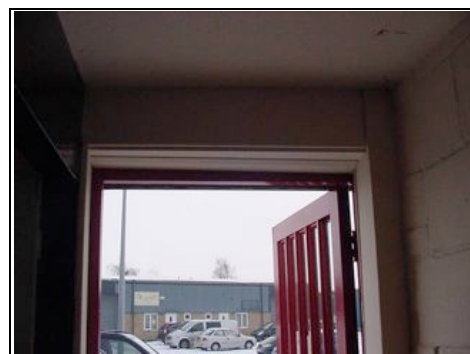
Marked, repairs and poor quality painting particularly around conduit  Dated	Repair, prepare and redecorate.  Clean
<b>Walls:</b> Painted blockwork	Dated	Repair, prepare and redecorate.
<b>Floors:</b> Poly vinyl  <b>Skirting:</b> Small poly vinyl skirting	Deterioration to right side	Deep clean or replace  Clean or replace

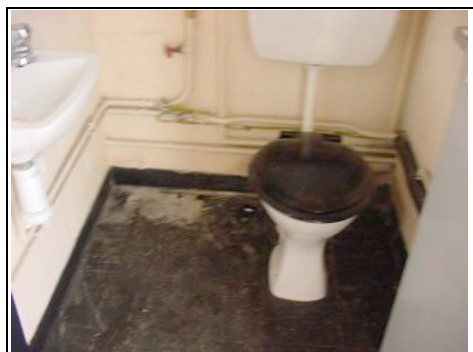
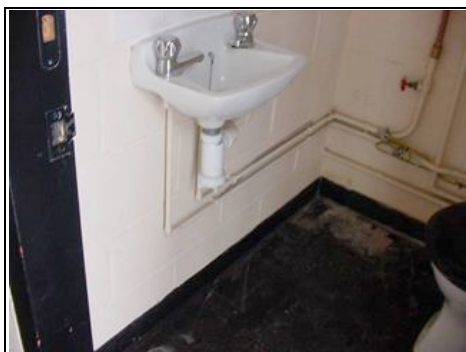
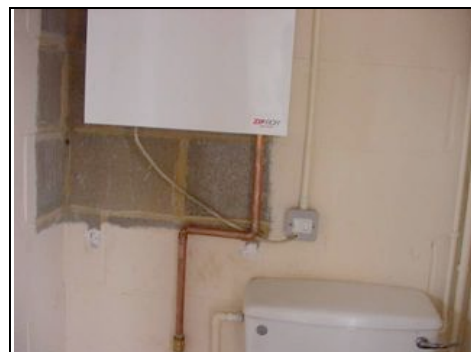
DESCRIPTION	CONDITION	ACTION REQUIRED
<b>Ceiling:</b>  Painted  Surface mounted conduit Bulkhead light	Dated  Dated	Repair, prepare and redecorate.  Clean
<b>Walls:</b>  Painted blockwork	Marked and missed around water heater	Repair, prepare and redecorate.
<b>Floors:</b>  Poly vinyl  <b>Skirting:</b> Small poly vinyl skirting		Deep clean or replace  Clean or replace

Stained Splashback tiling	Deep clean or replace
<b>Detailing:</b>  <b>Entrance door:</b> Painted Aluminium ironmongery	Marked	Repair, prepare and redecorate.
<b>Services:</b>  Zip RCH water heater

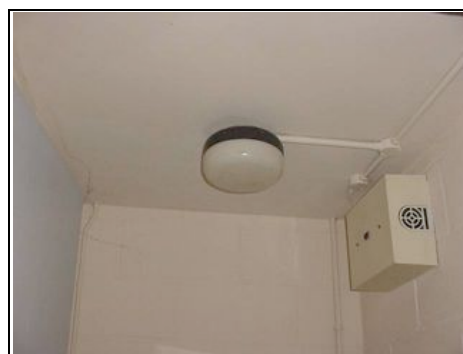
Extract system

<b>Entrance door:</b> Grey painted Aluminium ironmongery	Marked	Repair, prepare and redecorate.          Clean
<b>Services:</b>  Extract system	Not working.	Service
