SCHEDULE OF CONDITION

**Hampstead
London NW6 XXX**

We have been instructed to inspect and prepare a Schedule of Condition for Mrs X

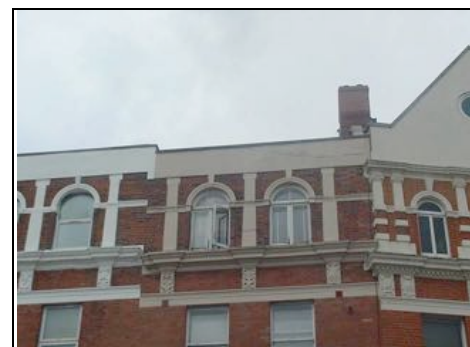
Deteriorating parapet wall

Limited view If there is a joint shared cost associated with the high level roof then a joint high level inspection with the landlord's surveyor to be carried out from high level cherry picker or equivalent is recommended.
Roofs: Hidden roof Rendered parapet wall	Not inspected Hairline cracking; likely to be leaking.	If there is a joint shared cost associated with the high level roof then a joint high level inspection with the landlord's surveyor to be carried out from high level cherry picker or equivalent is recommended. Repair.

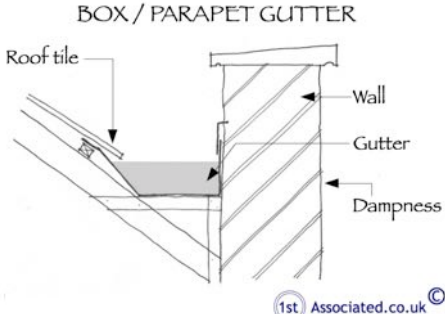
<p>Likely to be a hidden box gutter at high level</p>

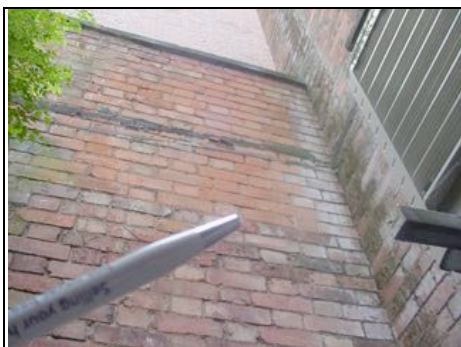
Rear elevation pattern staining and lichens

Make good brickwork where openings have been formed around the pipework. Ensure all gutters are watertight and falling towards the downpipe and clear. Repair downpipes and secure as necessary, ensure downpipes are clean and clear.

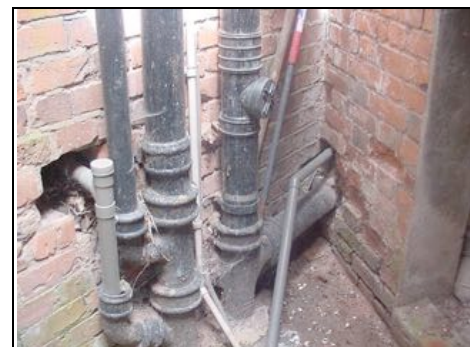
Holes around pipework

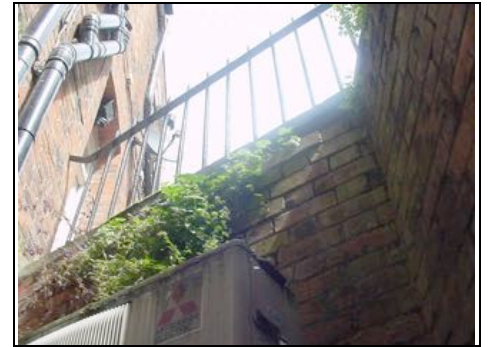
Vegetation growing from courtyard
walls

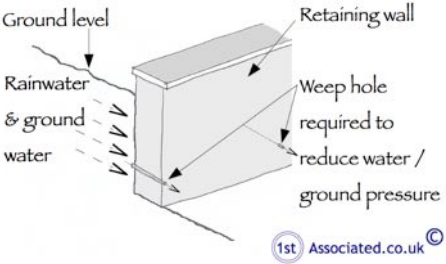
<p>Vegetation growth</p>   <p>Weathered brickwork and plants growing from brickwork Aerial view – 360 photo</p> <p>Weathered pointing</p> <p>No weep holes</p>	<p>Remove vegetation</p> <p>Ad hoc repointing</p> <p>Ideally add weep holes</p> <p>RETAINING WALLS & WEEP HOLES</p>

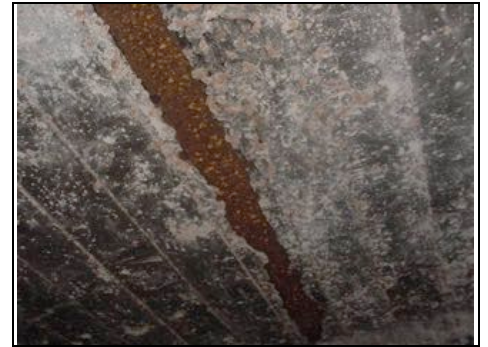
Concrete ceiling with metal lintel

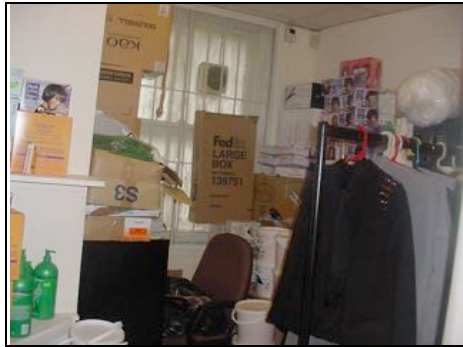
DESCRIPTION	CONDITION	ACTION REQUIRED
Ceiling: Suspended ceiling with ceiling grid	Dated Water damage to centre ceiling tile

Displaced/damaged tile to ceiling example left side

Repair, prepare and redecorate

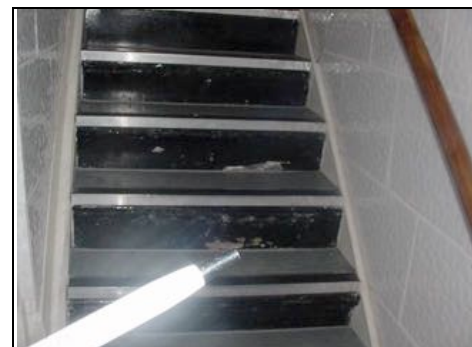
Damaged stairs
