SCHEDULE OF CONDITION

Islington
London. N1 XXX

FRONT EXTERNAL ELEVATION

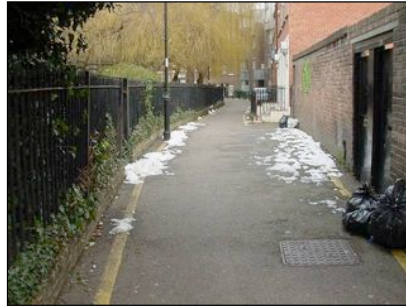
OUTSIDE AREAS

DESCRIPTION	CONDITION	ACTION REQUIRED
Alleyway to rear For record a view of access to rear courtyard area
