SCHEDULE OF CONDITION

XXXX

Mr X

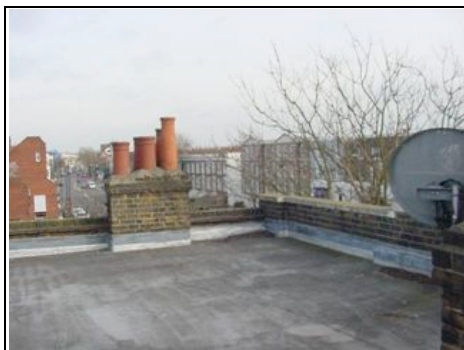
Main roof

View of main roof

Cracking to asphalt

DESCRIPTION	CONDITION	ACTION REQUIRED
Flat roof: Asphalt	Cracking visible within asphalt	Ad hoc repairs Over the period of the Lease we would expect the roof to require major repairs if not renewal
Chimneys: Numerous Brickwork	Ad hoc repairs required	Ad hoc repairs

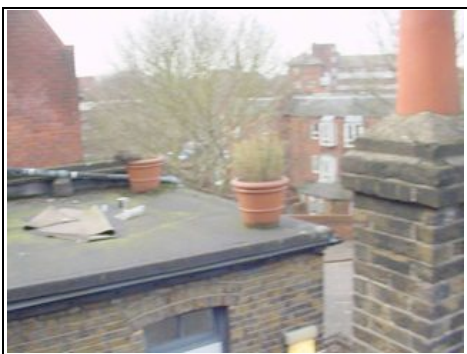
Rear two storey roof

Two storey rear roof

DESCRIPTION	CONDITION	ACTION REQUIRED
<p>Flat roof: Asphalt</p> <p>There are doors leading out to this area but no safety rail around the edge of the roof.</p>	<p>Debris</p> <p>Point load damage</p> <p>Redundant pipework around and adjacent to the roof</p>	<p>Remove</p>

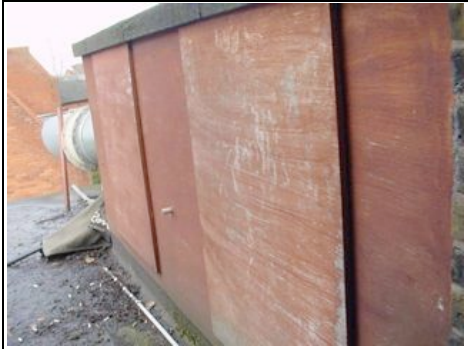
Two Storey Roof
(rear right)

Timber unit on rear right roof

Timber unit: Mineral felt roof	Dated	Sand, repair, prepare and re-stain.
--	-------	-------------------------------------

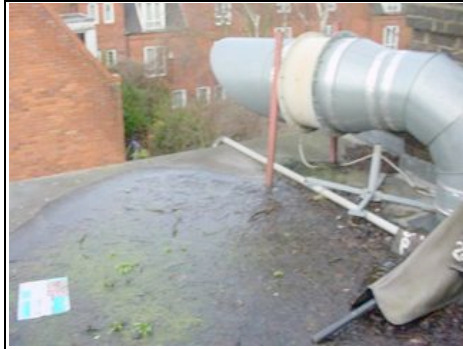
Rear right roof

DESCRIPTION	CONDITION	ACTION REQUIRED
Flat Roof: Asphalt No fall	Debris Leaves gathering at base of property	Remove
Chimneys: Brickwork	Ad hoc repairs	Ad hoc repairs

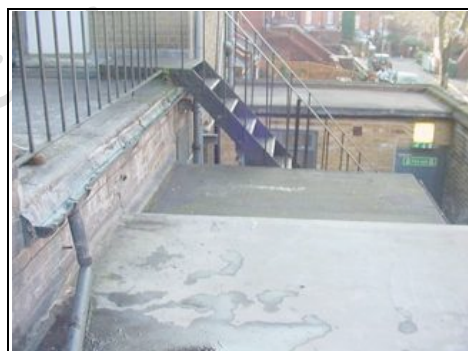
Rear low level roof

View of rear single storey flat roofs

DESCRIPTION	CONDITION	ACTION REQUIRED
Flat Roof: Asphalt	Leaves and moss sitting on the roof indicating lack of fall to roof	Clear

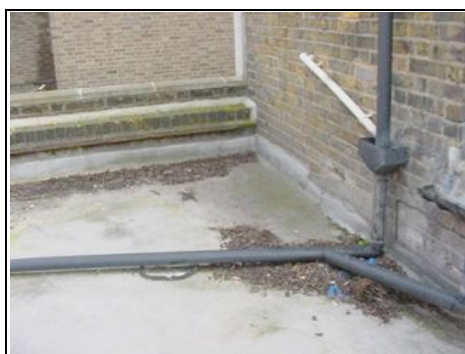
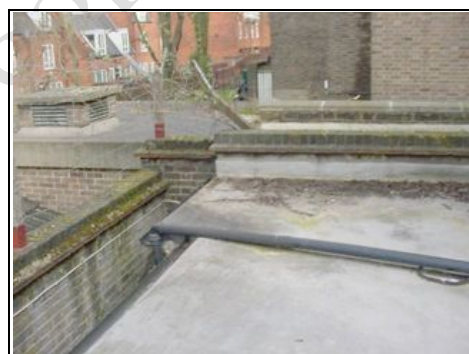
Low level single storey roof

Rear roof right

Rear flat roof right

DESCRIPTION	CONDITION	ACTION REQUIRED
Flat Roof: Asphalt Metal fire escape

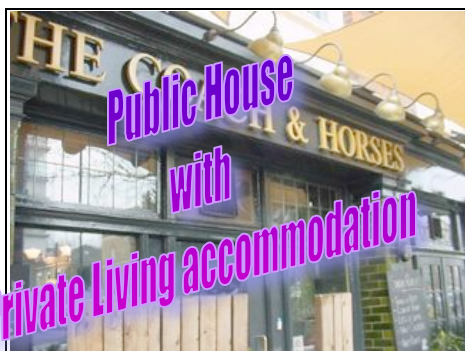
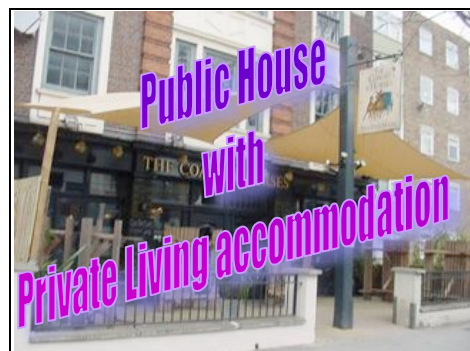
Front Elevation

Front view

Front view with beer garden

DESCRIPTION	CONDITION	ACTION REQUIRED
Roofs:		Please see roof section
Parapet Wall: Brickwork		Please see roof section
Gutters and Downpipes: Cast Iron and Plastic		Please see roof section
Walls: Flemish bond brickwork Painted Render Glazed tiles	Dated Dated. Graffiti Cracked	Clean Clean graffiti and redecorate if required Repair

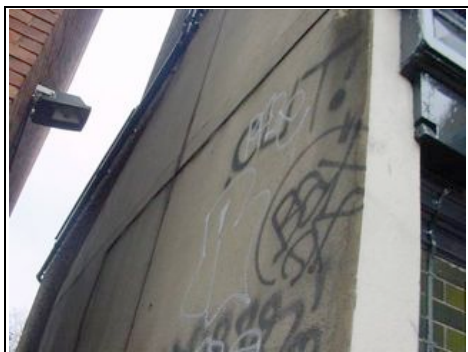
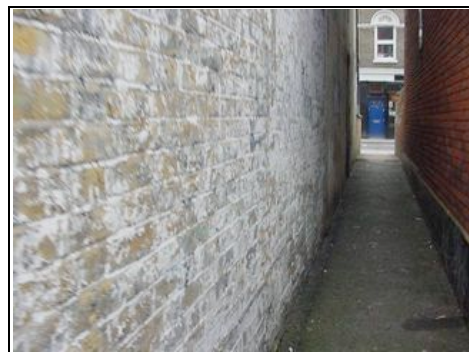
Left side view

Left view at low level

DESCRIPTION	CONDITION	ACTION REQUIRED
Roofs:		See roof section.
Gutters and Downpipes: Cast Iron and Plastic		See roof section.
Walls: Flemish bond brickwork White painted panel Render	Graffiti covered	Clean graffiti and redecorate if required.

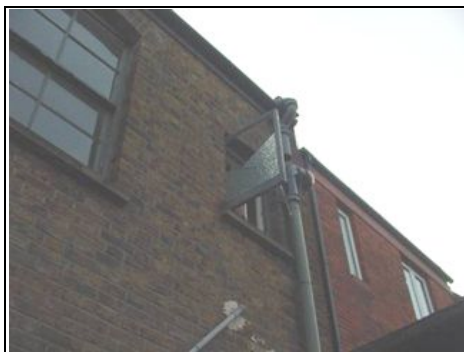
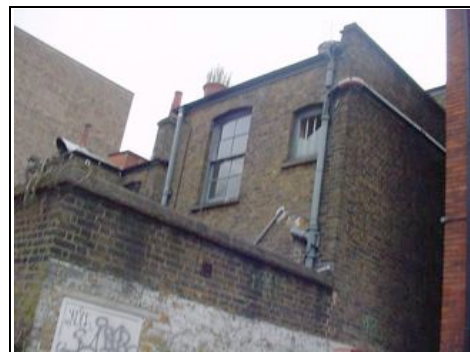
View of rear windows

Rear view

DESCRIPTION	CONDITION	ACTION REQUIRED
Chimneys: Brickwork		See roof section.
Roofs:		See roof section.
Gutters and Downpipes: Cast Iron and Plastic	Leaking Waste pipes going into rainwater pipes	Make watertight. Adjust pipework

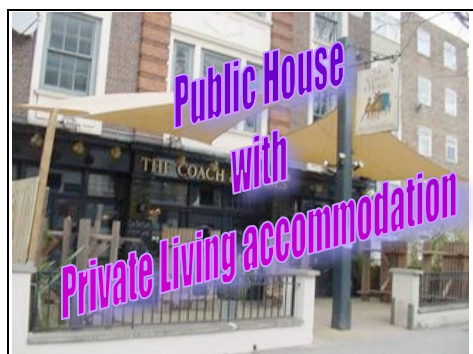
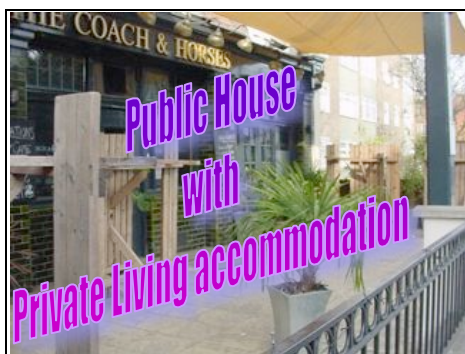
OUTSIDE AREAS

Front beer garden

Beer garden area to front

DESCRIPTION	CONDITION	ACTION REQUIRED
Front beer garden area Paved Rendered wall with metal railing	Dated Dated, damaged render	Pressure hose and clean Repair, prepare and redecorate

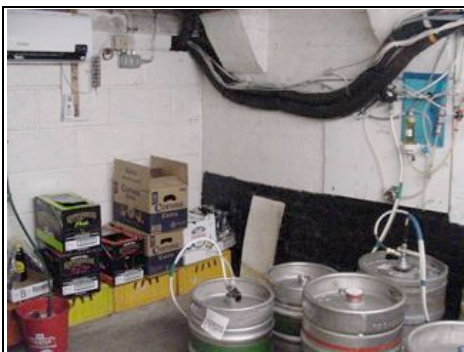
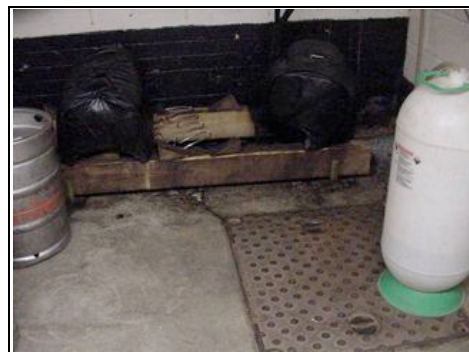
View in cold cellar

Cold cellar

DESCRIPTION	CONDITION	ACTION REQUIRED
Ceilings: Suspended ceiling system Behind ceiling joist and floorboard with embedded timbers	Dampness/deterioration to approx quarter of ceiling Approx one tenth of ceiling missing Mould and marked Rot	Make watertight Supply and fit new insulated ceiling

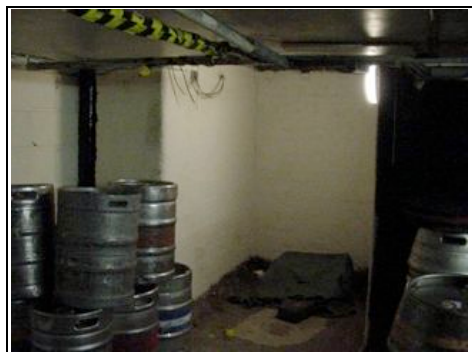
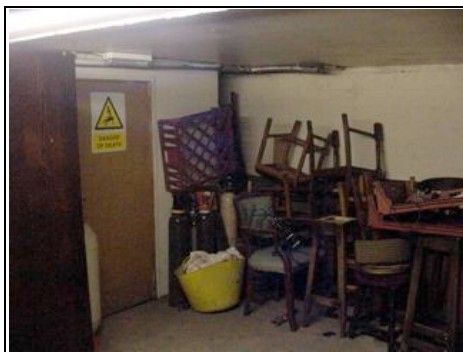
Main Cellar

View of Main Cellar

Floors:		
Concrete	Heavily damaged	Screed and add floor paint.

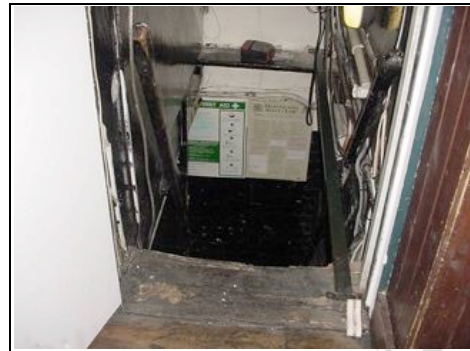
Steep ladder steps

Steps to cellar

DESCRIPTION	CONDITION	ACTION REQUIRED
Steps: Steep Hand rail	Dated	Repair, prepare and redecorate. Secure

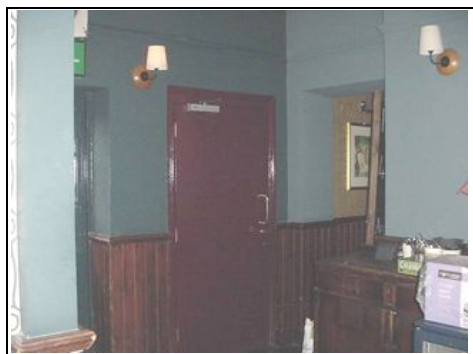
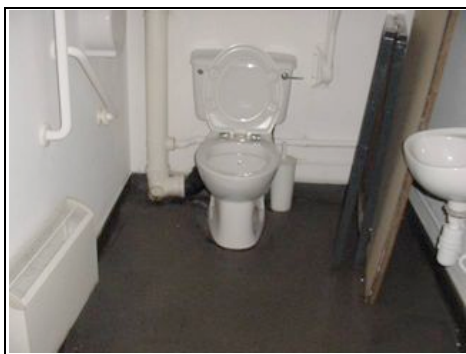
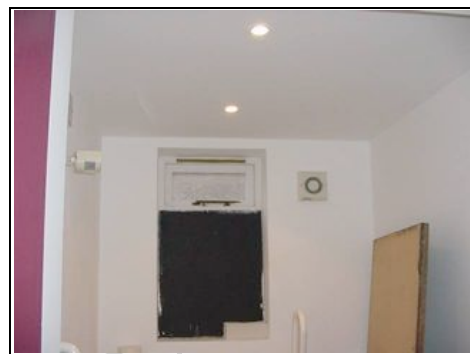
Disabled/Less Able Toilets (middle, rear)

DESCRIPTION	CONDITION	ACTION REQUIRED
Ceilings: Painted Two spotlights	Average	Repair, prepare and redecorate.
Walls: Painted	Dated	Repair, prepare and redecorate.
Floors: Altro style	Ingrained dirt	Deep clean particularly to entrance door area
Sanitary Ware: WC, wash hand basin and assistance handles	Dated	Deep Clean

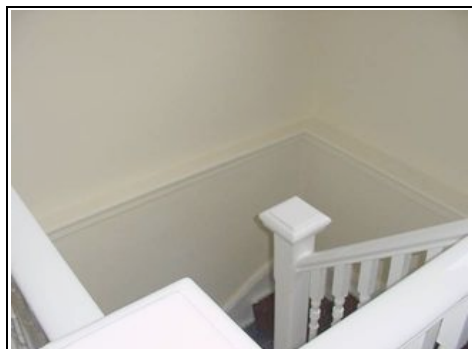
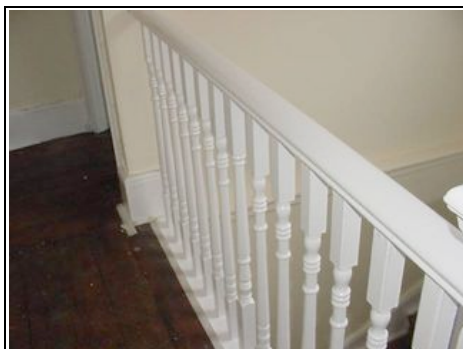
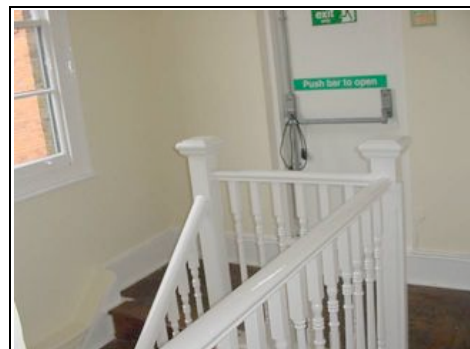
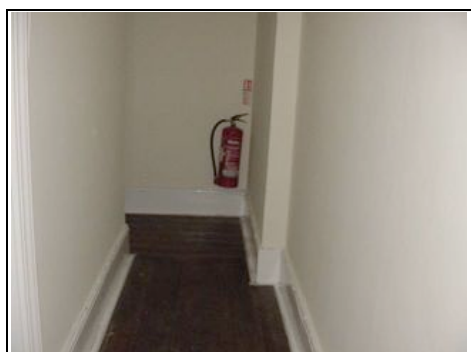
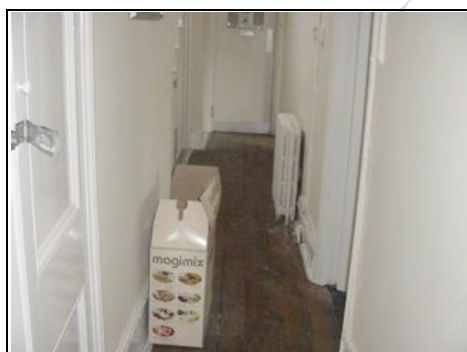
Access from Ground Floor to First Floor

DESCRIPTION	CONDITION	ACTION REQUIRED
Ceilings: Painted	Newly painted	
Walls: Painted – stipple effect	Newly painted.

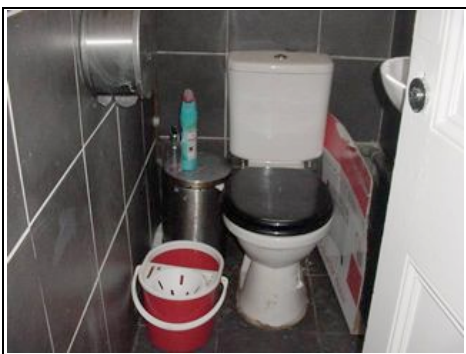
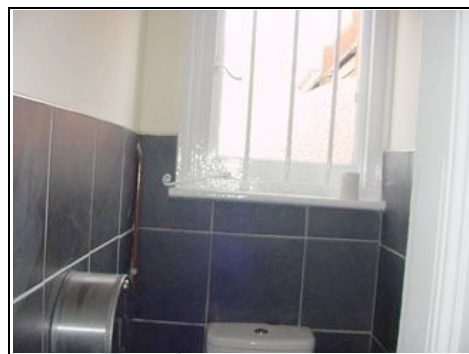
Toilet

Broken window

DESCRIPTION	CONDITION	ACTION REQUIRED
Ceilings: Painted	Newly painted	
Walls: Painted Tiled to approx 1.5m	Newly painted Modern	
Floors: Tiled	Ingrained dirt	Deep clean
Sanitary Ware: WC	Ingrained dirt	Deep Clean
Detailing: Windows: Doors:	Broken Newly painted	Repair, prepare and redecorate.

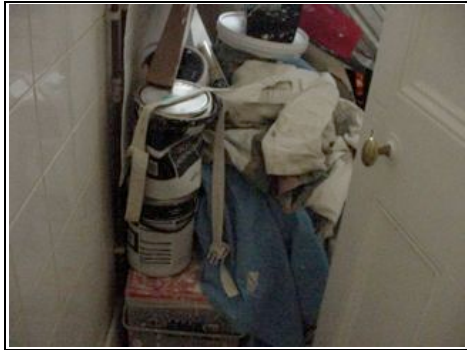
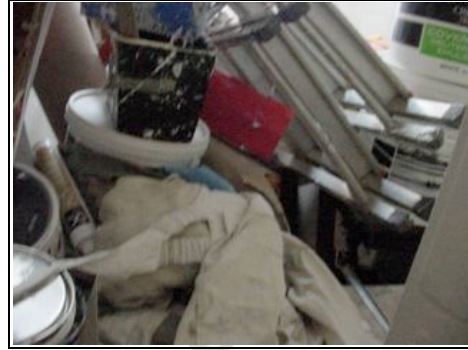
Bathroom
(rear)

Unable to gain access to this room at the time of our inspection – mass of stored items

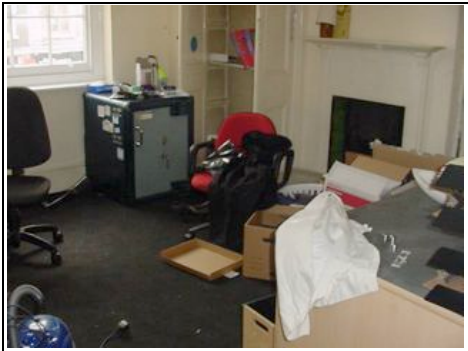
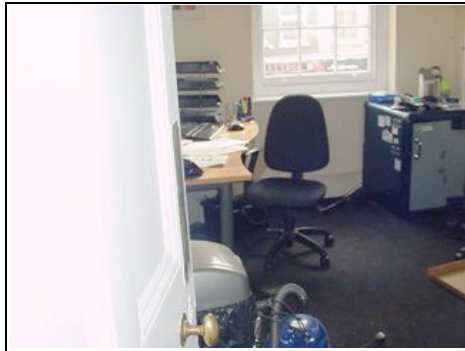
Office
(front left)

DESCRIPTION	CONDITION	ACTION REQUIRED
Ceilings: Papered	Staining right corner	Repair, prepare and redecorate.

Walls: Woodchip wallpaper	Dated and marked	Repair, prepare and redecorate.
Floors: Carpet	Dated	Clean/replace

Detailing:		
Windows: Sliding sash windows	Dated	Repair, prepare and redecorate.
Doors: Panel door	Dated	Repair, prepare and redecorate.
Built in cupboard	Dated and marked	Repair, prepare and redecorate.

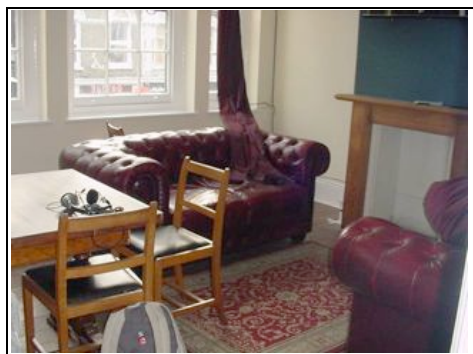
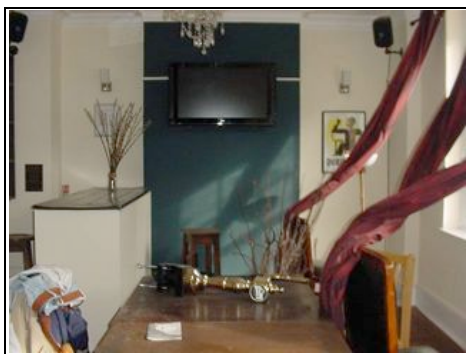
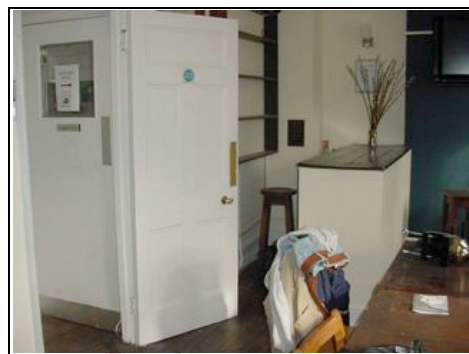
Bar/Function Room/Lounge (right)

DESCRIPTION	CONDITION	ACTION REQUIRED
Ceilings: Painted	Average	Repair, prepare and redecorate.
Walls: Painted	Being painted at the time of our survey	
Floors: Floor boarding	Dated and marked	Sand, prepare, repair and re-stain.

Detailing: Windows: Three sliding sash windows; two 6x6 one 2x2 Doors: Painted panel door Bar: Painted, floorboarding to top	Dated Dated Dated	Repair, prepare and redecorate. Repair, prepare and redecorate. Repair, prepare and redecorate.
--	---------------------------------	---

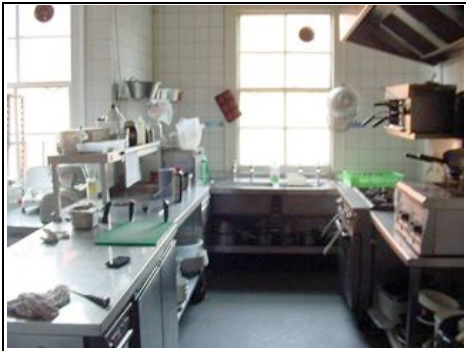
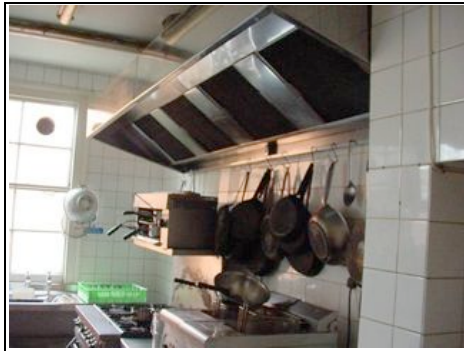
Catering Kitchen
(rear right)

DESCRIPTION	CONDITION	ACTION REQUIRED
Ceilings: Painted Three bulk head lights	Dated Paint marked	Repair, prepare and redecorate. Clean
Walls: Floor to ceiling tiles	Ingrained dirt	Deep clean

Floors:		
Altro style	Ingrained dirt Damage	Repair and deep clean

Detailing:		
Windows: Sliding sash	Taped up ready for painting	Repair, prepare and redecorate.
Entrance door with vision panel		
Dumb waiter: left		
Access to roof

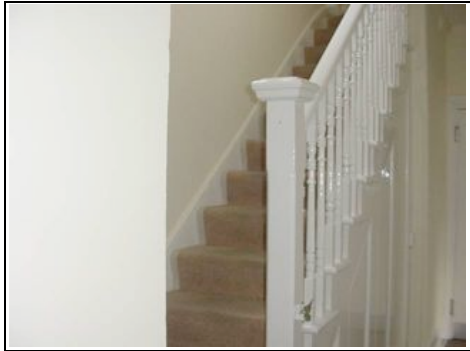
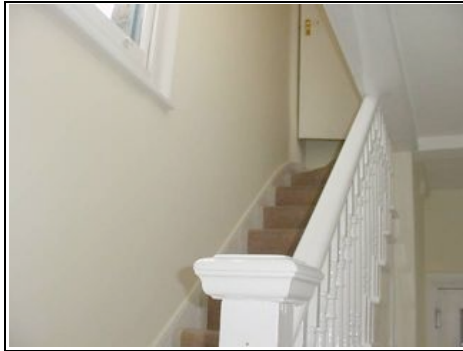
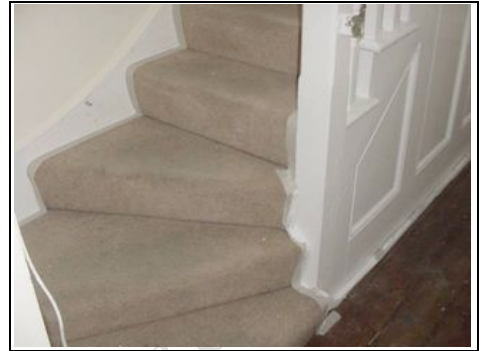
Stairs

DESCRIPTION	CONDITION	ACTION REQUIRED
Ceilings: Painted	Newly painted	
Walls: Painted	Newly painted	
Floors: Carpet

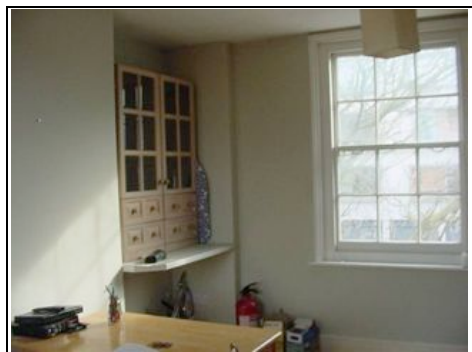
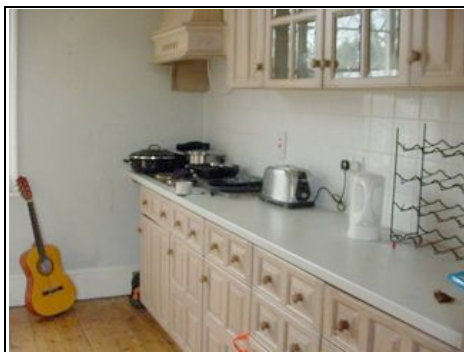
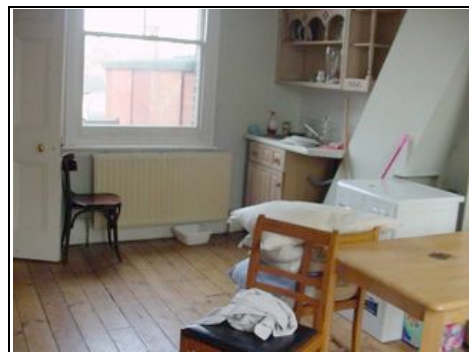
Domestic Kitchen/Dining Room

DESCRIPTION	CONDITION	ACTION REQUIRED
Ceilings: Painted	Dated	Repair, prepare and redecorate.
Walls: Painted Removed wall	Dated No pier	Repair, prepare and redecorate.

Floors:		
Boarding	Dated and repairs	Sand, repair, prepare and re-stain.

Detailing:		
Windows: Two sliding sash windows	Dated	Repair, prepare and redecorate.
Doors: Painted panel	Dated	Repair, prepare and redecorate.
Chimneybreast; right	Needs venting	Add vents

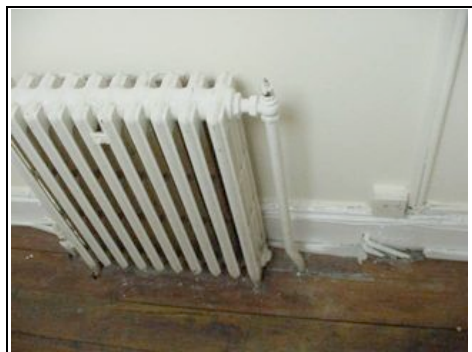
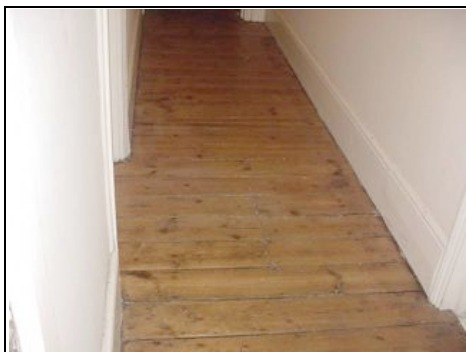
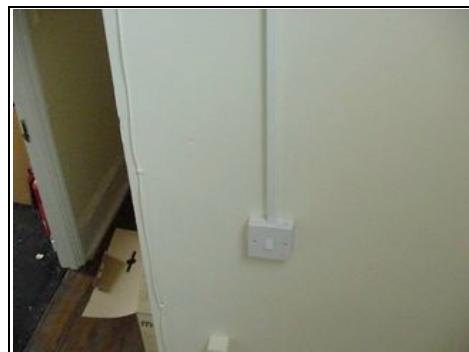
Corridor

DESCRIPTION	CONDITION	ACTION REQUIRED
Ceilings: Painted	Dated Hairline cracking around lights	Repair, prepare and redecorate.
Walls: Painted	Dated and marked	Repair, prepare and redecorate.

Floors: Timber	Marked	Sand, repair, prepare and re-stain.
--------------------------	--------	-------------------------------------

Detailing: Windows: Georgian wire, polished plated giving borrowed light onto adjoining staircase. Doors: Vision panel	Dated	Repair, prepare and redecorate.
---	-------	---------------------------------

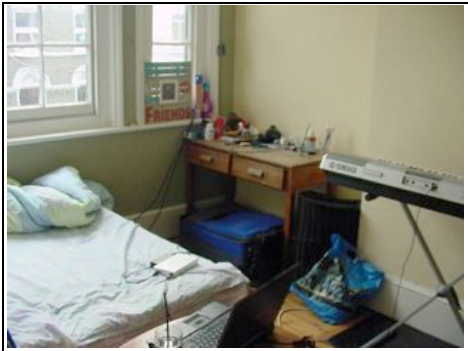
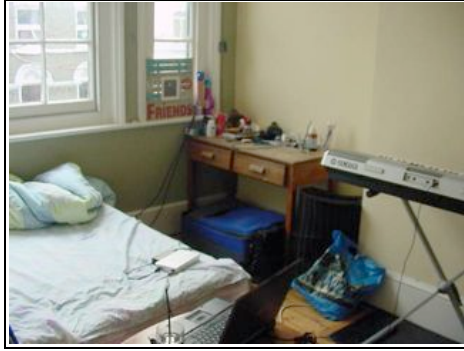
Bedroom One (middle)

DESCRIPTION	CONDITION	ACTION REQUIRED
Ceilings: Painted	Dated	Repair, prepare and redecorate.
Walls: Painted Wall removed	Heavily marked to fireplace area Hairline cracking No pier	Repair, prepare and redecorate.

Floors:		
Timber	Damaged	Make good, Sand, repair, prepare and restain.

Detailing:		
Windows:		
One 6x6 sliding sash window	Dated	Repair, prepare and redecorate.
Two 2x2 sliding sash windows	Dated	Repair, prepare and redecorate.
Door: Painted panel	Dated	Repair, prepare and redecorate.

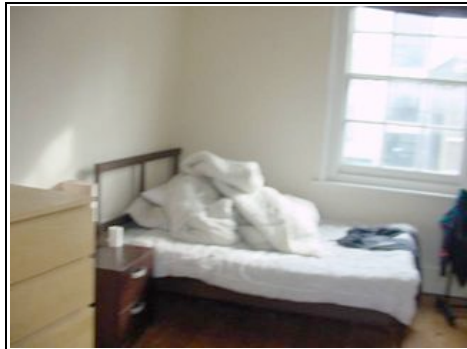
Bedroom Two
internal with en suite
(left)

DESCRIPTION	CONDITION	ACTION REQUIRED
Ceilings: Painted	Dated	Repair, prepare and redecorate.
Walls: Painted	Heavily marked Old fixing points	Repair, prepare and redecorate.

Floors:		
Timber	Dated	Sand, repair, prepare and re-stain.

Detailing:		
Doors: To roof	Dated	Repair, prepare and redecorate or replace.

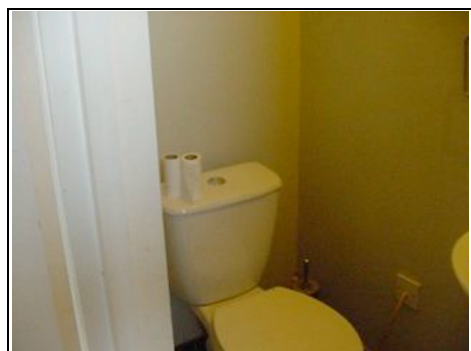
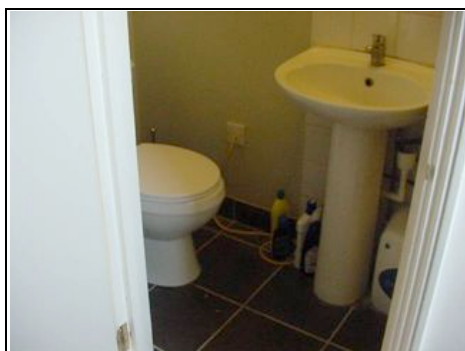
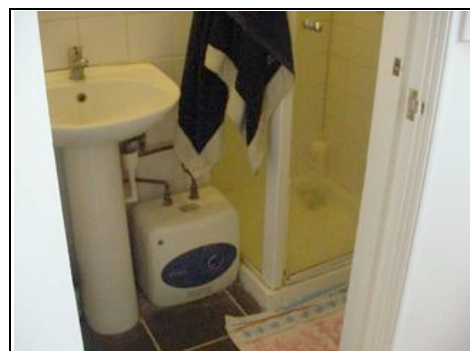
En suite (internal)

DESCRIPTION	CONDITION	ACTION REQUIRED
Ceilings: Painted	Dated	Repair, prepare and redecorate.
Walls: Painted	Heavily marked Old fixing points	Repair, prepare and redecorate.

Sanitaryware: WC, wash hand basin and shower	Ingrained dirt	Deep clean
Detailing: Doors: Hollow core flush door	Dated	Repair, prepare and redecorate.
